Town of Callicoon

Youngsville Water District Water Tank Replacement Project

2022 New York State Consolidated Funding Application

May 31, 2022

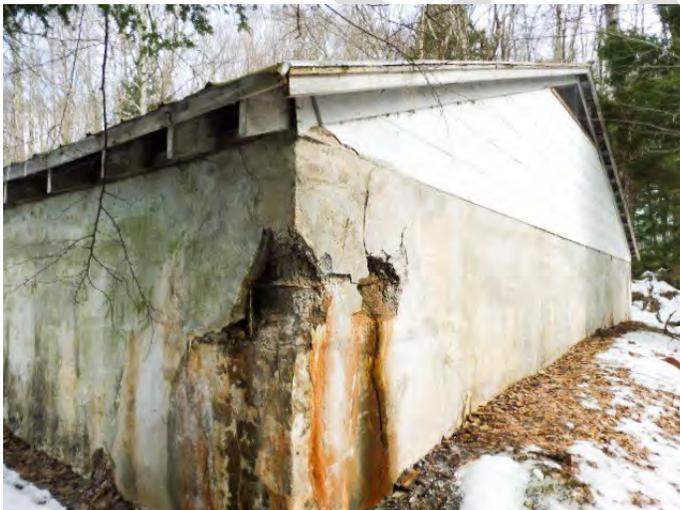
Water tank – Southwest Corner

As can be seen in the photo, the concrete shows signs of severe distress and is clearly failing. This condition likely began with the appearance of hairline fractures that allowed water to seep into the concrete, rusting the reinforcement bar. The oxidized iron bar swells and separates from the concrete causing more cracking, spalling and eventually disintegration.

The vertical rust lines in the photo are indicative of the early stages of this process.

The visible portion of the concrete shows signs of cracking, spalling, and excessive corrosion of the now exposed reinforcement bar. This condition is likely compounded by the annual freeze/thaw cycle which causes further deterioration of the concrete.

The tank side wall depth is reported as 12', and the majority of the tank is buried in the ground. As such, the condition of the sub-surface tank cannot be determined.

Given the distressed condition of the exposed portion of the tank, it is unlikely that the buried portion of the tank has retained its integrity.

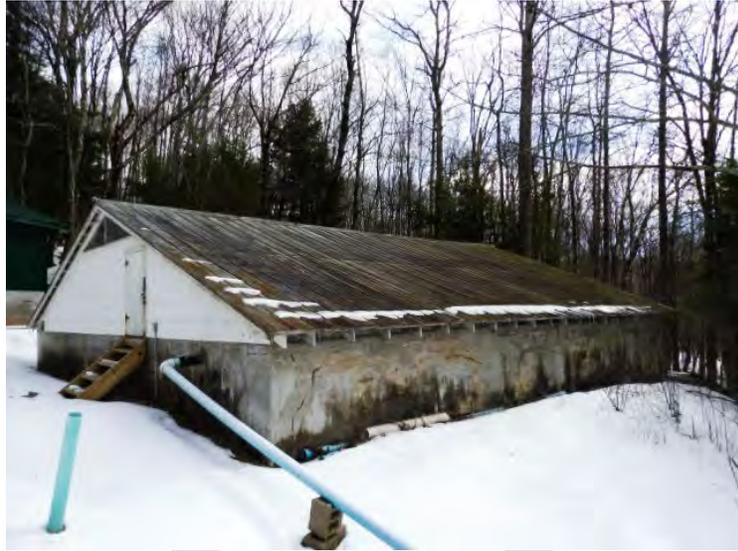
Water Storage Tank

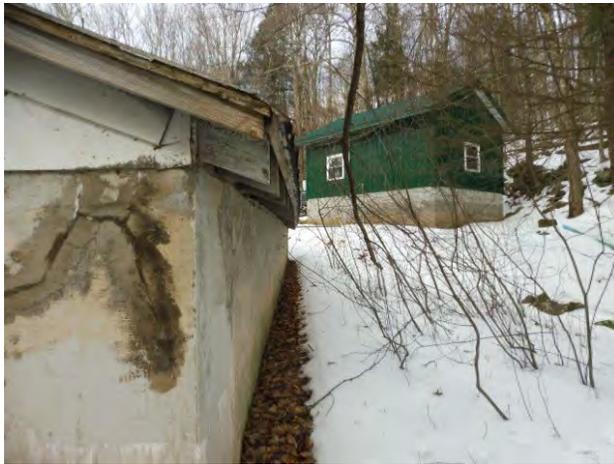
Water Tank - Northwest Corner

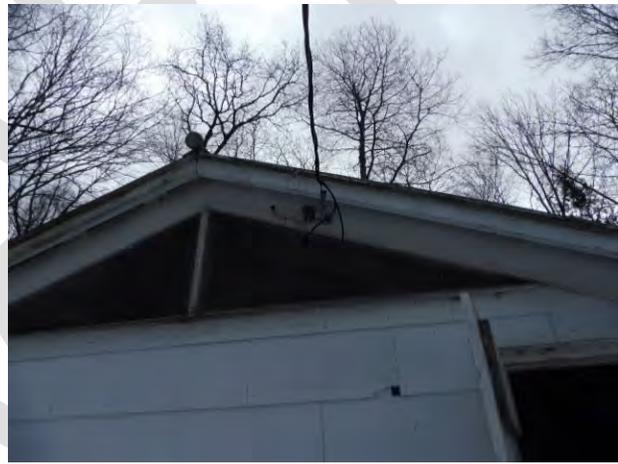
Screened Gable Vents

- 2) Vented gable ends and voids in the structure envelope provide inadequate protection from contamination.

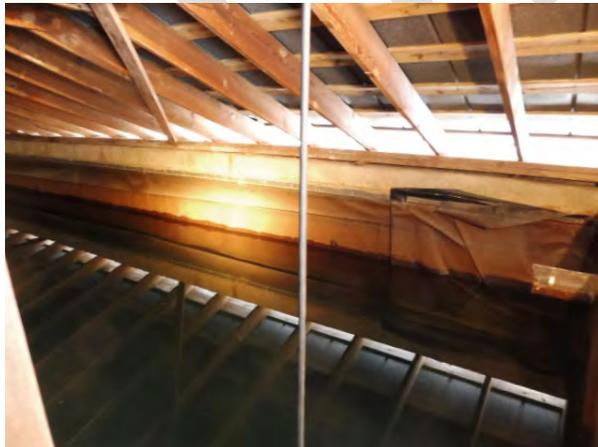
Tank Interior with plastic liner

21. The plastic liner was not containing the water. Flashlight pictures at the large hole in the corner show the water maintaining its level outside the liner. This must be repaired.

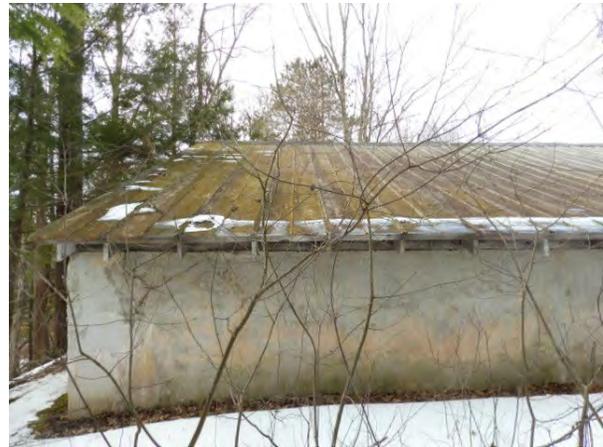
Metal Roof

The overall condition of the tank is poor and the roof is showing signs of age and disrepair. The DOH survey identified two active leaks in the tank. Although no measurements were made to determine the leakage rate, the DOH visual inspection concluded that water loss is in the range of 6-12 gallons per minute, upwards of 17,000 gpd.
